S-259
Rumblay Point Road House
Tulls Corner vicinity
private

**Maryland Historical Trust
State Historic Sites Inventory Form**

Survey No. S-259

and/or common Rumbley Point Road House

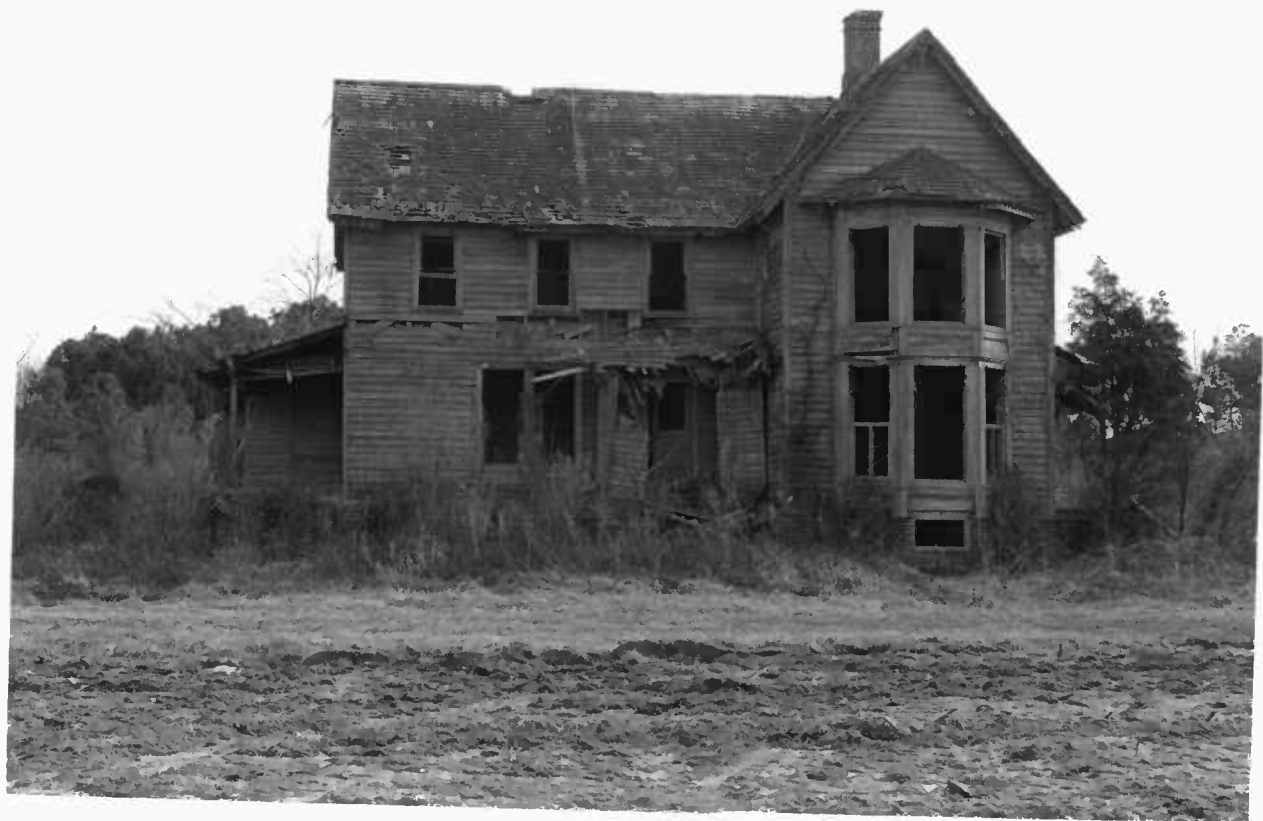
Rumbley Point Road House S-259
Near Marumscot, Somerset County
North Elevation
4/85, Photographer, Paul Touart
Neg./MD. Historical Trust

The north and south gable ends are essentially alike with a two-story semi-octagonal bay window. Three windows light each floor and are divided by flat panels at the second floor level. The eave is also trimmed with Victorian sawnwork.

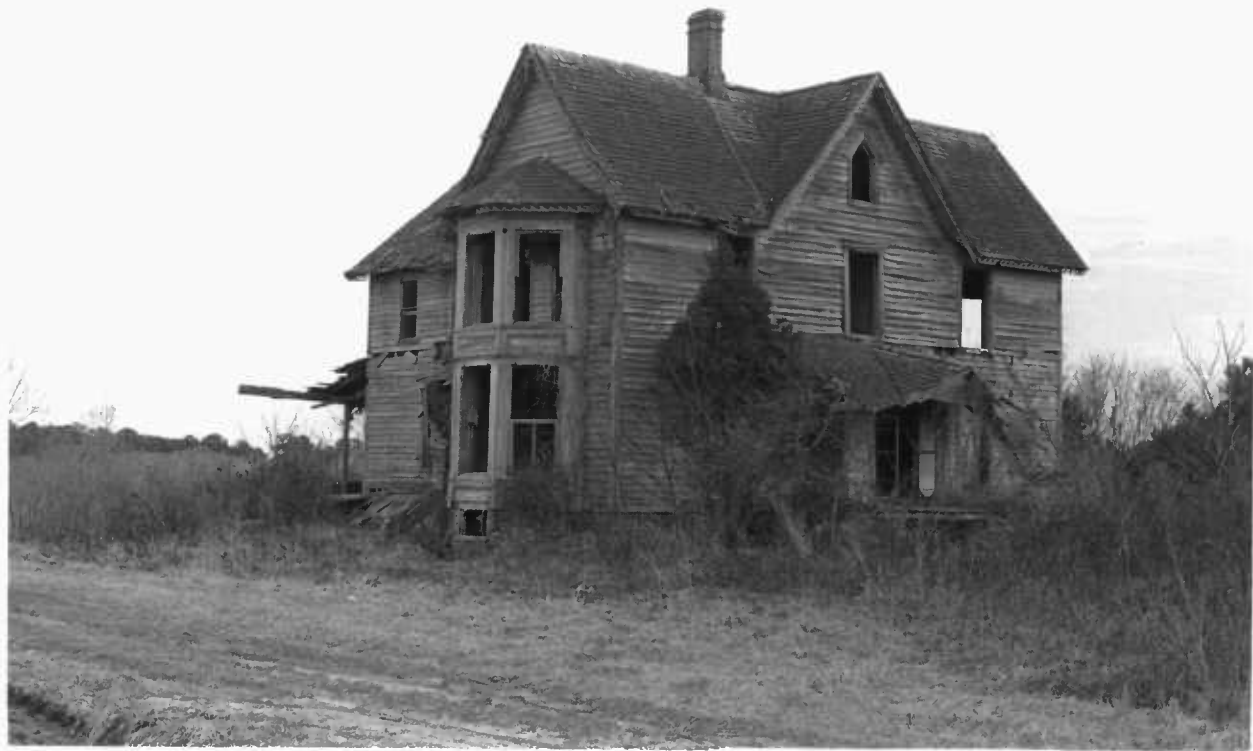
Rumbley Point Road House S-259
Near Marumscot, Somerset County
Northwest Elevation
4/85, Photographer, Paul Touart
Neg./MD. Historical Trust

The west (main) elevation is symmetrically arranged with a center door and flanking window sash, Now all broken out. A collapsed shed porch formerly covered the first floor, while the second floor is lighted by three evenly spaced windows. The cross-gable is pierced by a pointed arch window. The eaves of the roof extend beyond the wall surface and are trimmed with Victorian sawnwork. Rising from the roof is a single corbelled cap brick chimney. The other stack on the south side has been leveled off.

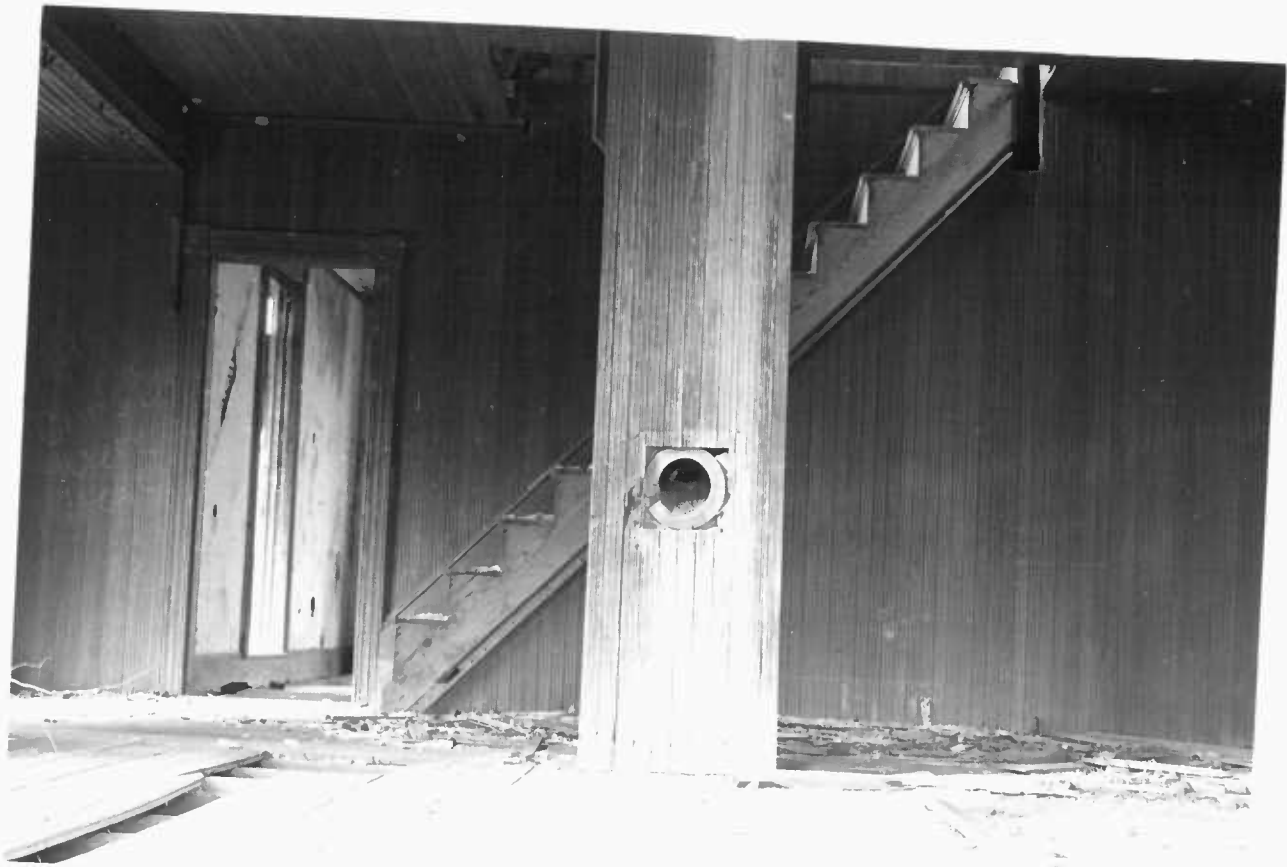
Rumbley Point Road House S-259
Near Marumsco, Somerset County
Parlor And Hall
4/85, Photographer, Paul Touart
Neg./MD. Historical Trust

The interior has been stripped of much of its decorative woodwork including spindled screens between the center hall and south room along with the newel post and balustrade. The south room does retain its narrow vertical board sheathing and a few fluted door surrounds with bulls-eye blocks. The brick stove stack is covered with narrow beaded board as well.

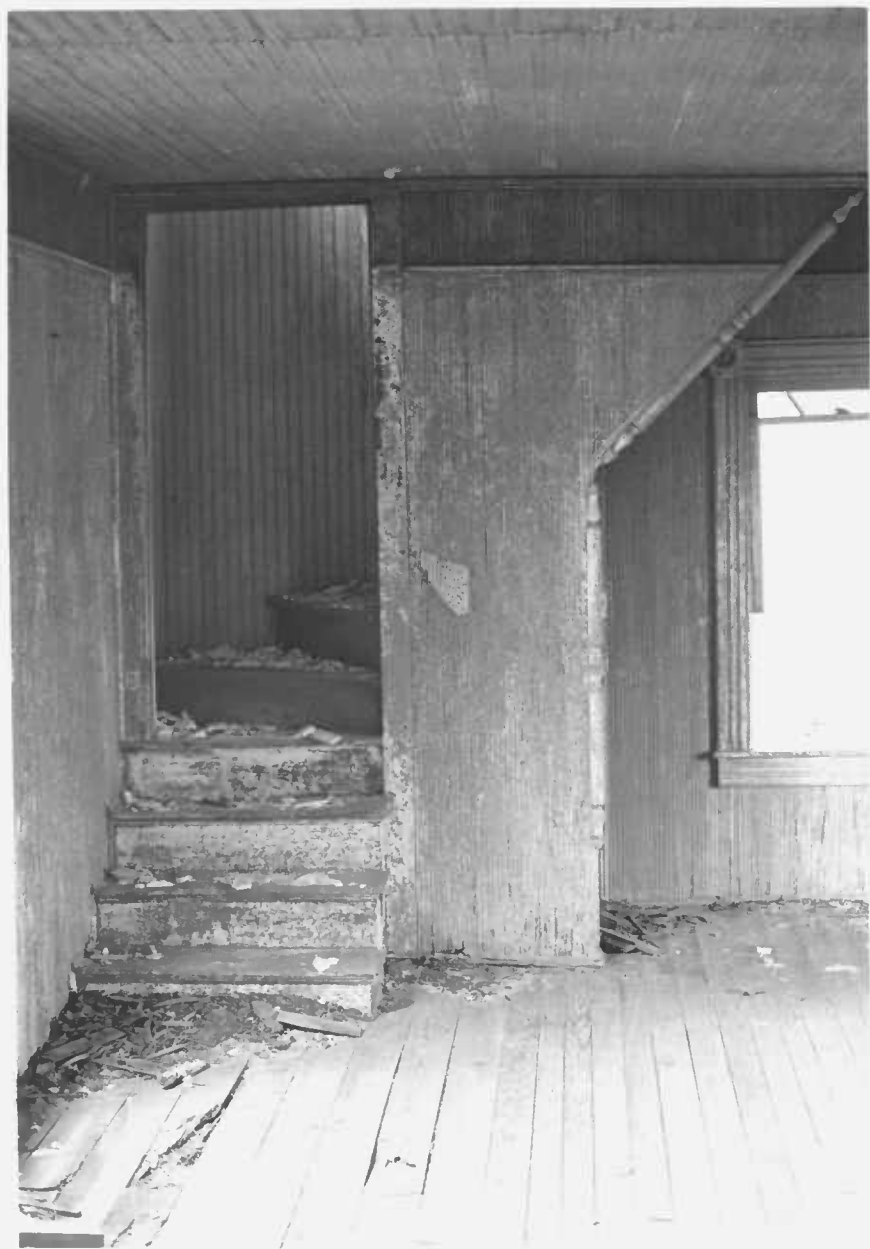
Rumbley Point Road House S-259
Near Marumscot, Somerset County
Kitchen Interior
4/85, Photographer, Paul Touart
Neg./MD. Historical Trust

The first floor of the service wing is one large rectangular room also sheathed with vertical beaded board. In the middle of the room, the brick stove stack rises through the ceiling and is encased with beaded board sheathing. An unusual decorative ceiling trim surrounds the stack. Fixed in the southeast corner is a built-in cupboard, and in the northeast corner the enclosed winder stair provides second floor access. The outside corners of the boxed stair are trimmed with turned spindles to

5-259
protect the corners from damage. The ceiling is also covered with beaded board. An unusual survival in this room is the paint scheme. White walls are contrasted with a narrow cornice and a bright yellow picture rail. The bulls-eye corner blocks are multi-colored.
